AIRESEARCH MFG CO OF ARIZONA PHOENIX  
RELIABILITY DATA FOR FLUIDIC SYSTEMS.(U)

4. TITLE (and Subtitle) RELIABILITY DATA FOR FLUIDIC SYSTEMS	5. TYPE OF REPORT & PERIOD COVERED Final Engineering Report 11 Apr 72-30 Jun 76	6. PERFORMING ORG. REPORT NUMBER 76-411479

7. AUTHOR(s) Wallis T. Fleming Harry R. Gamble	8. CONTRACT OR GRANT NUMBER(s) DAAG39-72-C-0092	
9. PERFORMING ORGANIZATION NAME AND ADDRESS AiResearch Manufacturing Company of Ariz. A Division of The Garrett Corporation Phoenix, Arizona	10. PROGRAM ELEMENT, PROJECT, TASK AREA & WORK UNIT NUMBERS Program element: 6.21.14.A

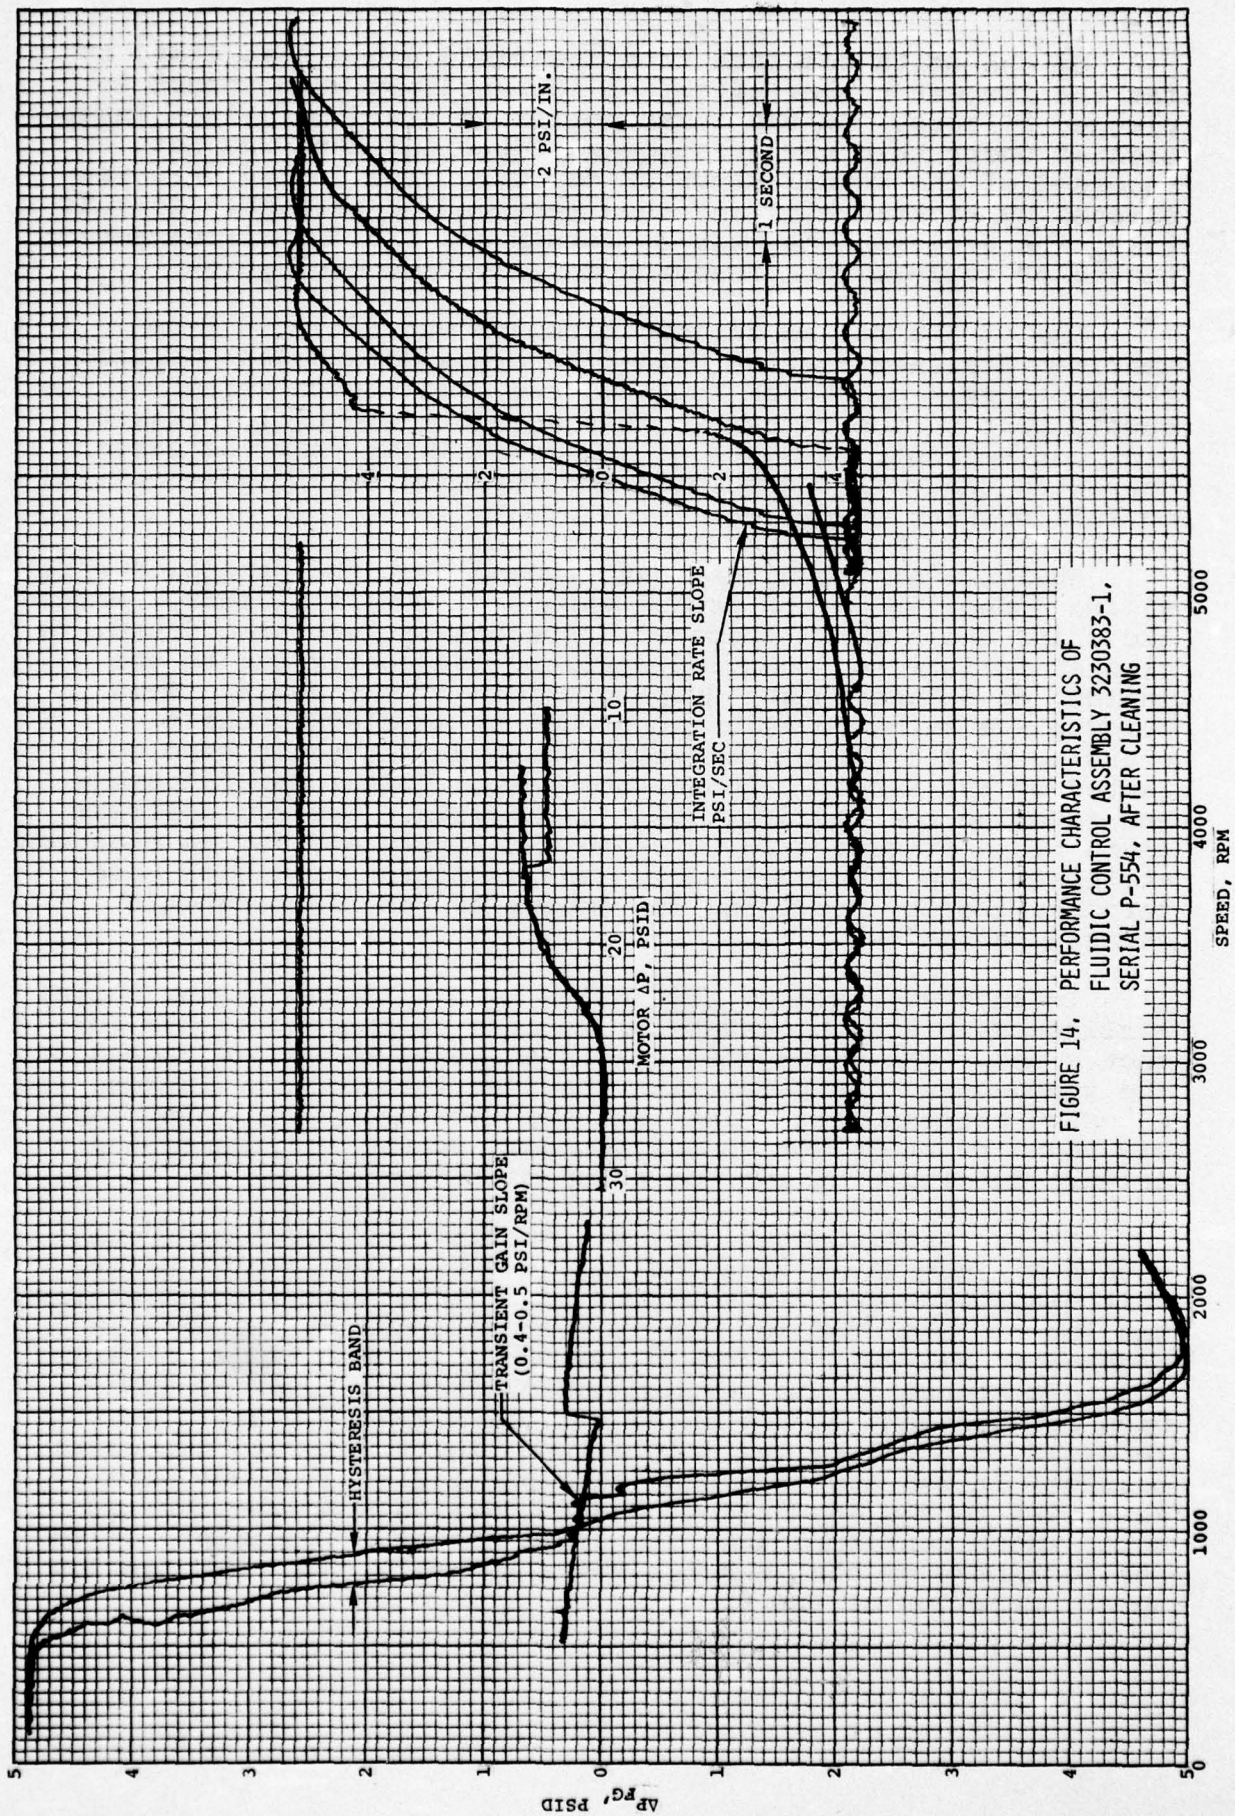
FIGURE 14. PERFORMANCE CHARACTERISTICS OF  
FLUIDIC CONTROL ASSEMBLY 3230383-1,  
SERIAL P-554, AFTER CLEANING

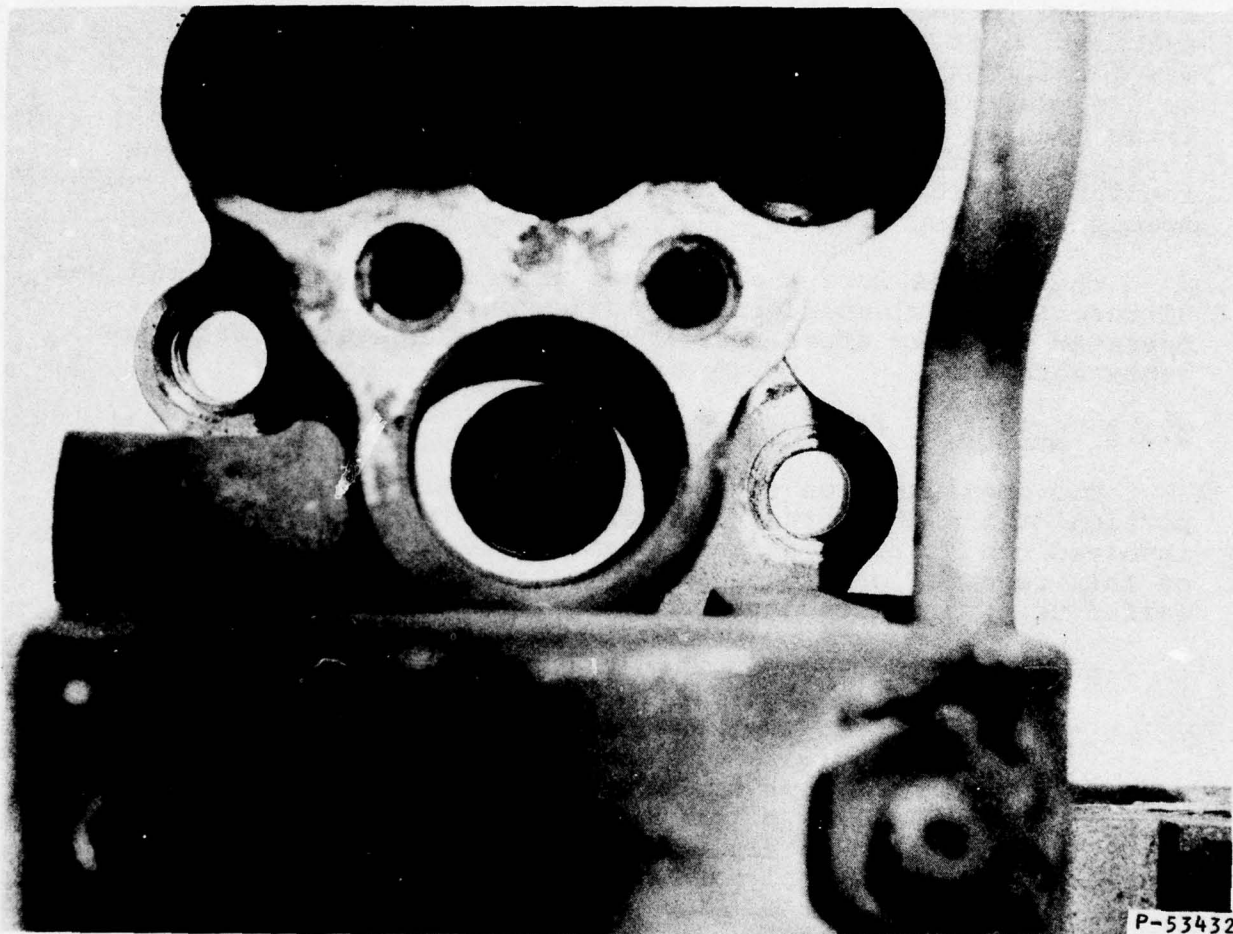
Figure 15. Failed Fluidic Circuit Returned from Field  
Depicting Contamination Caused From  
Electrostatic Charging of Silica Particles.

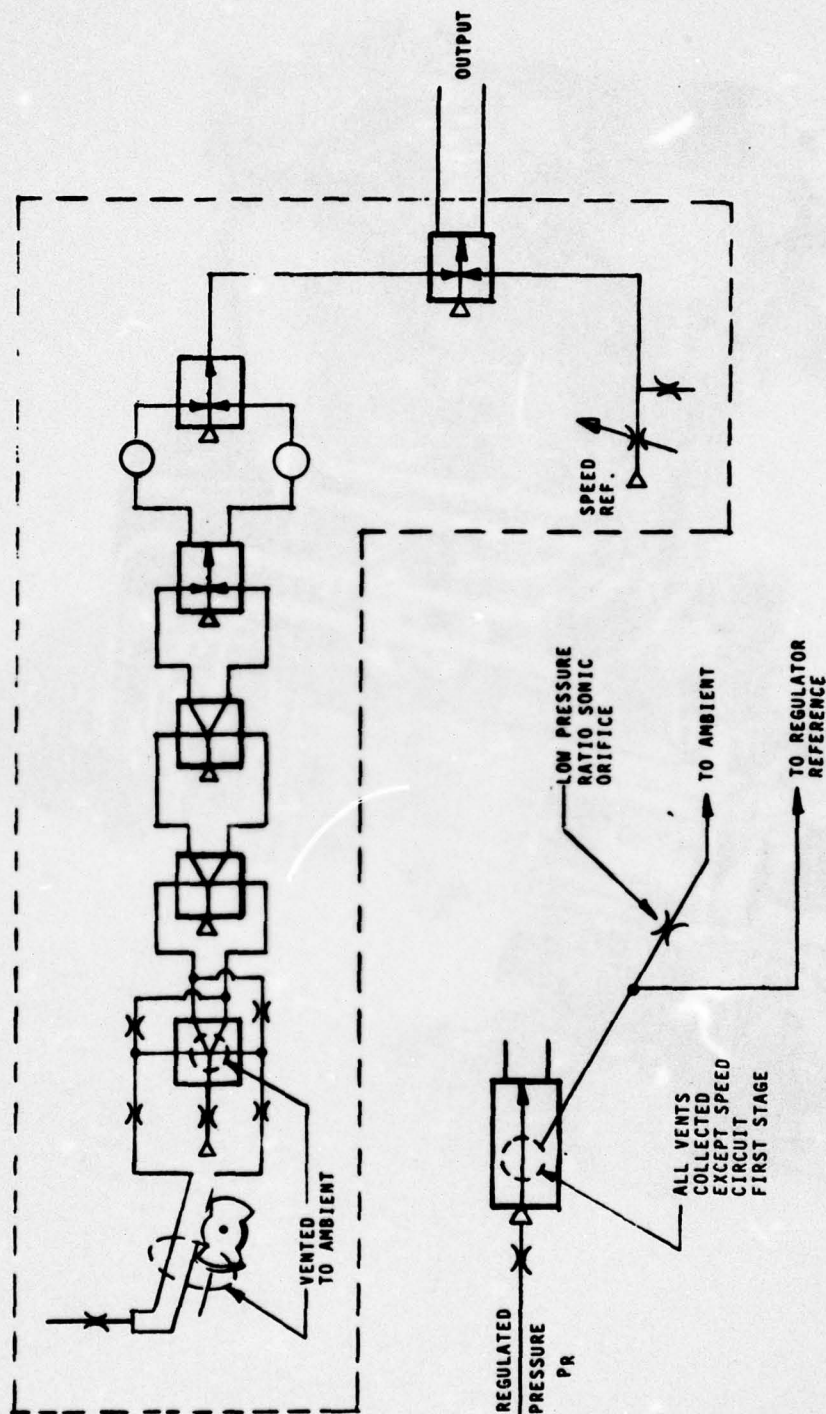
Figure 16. Fluidic Speed Control System on Thrust Reverser and Nozzle Control of Concorde SST Aircraft.

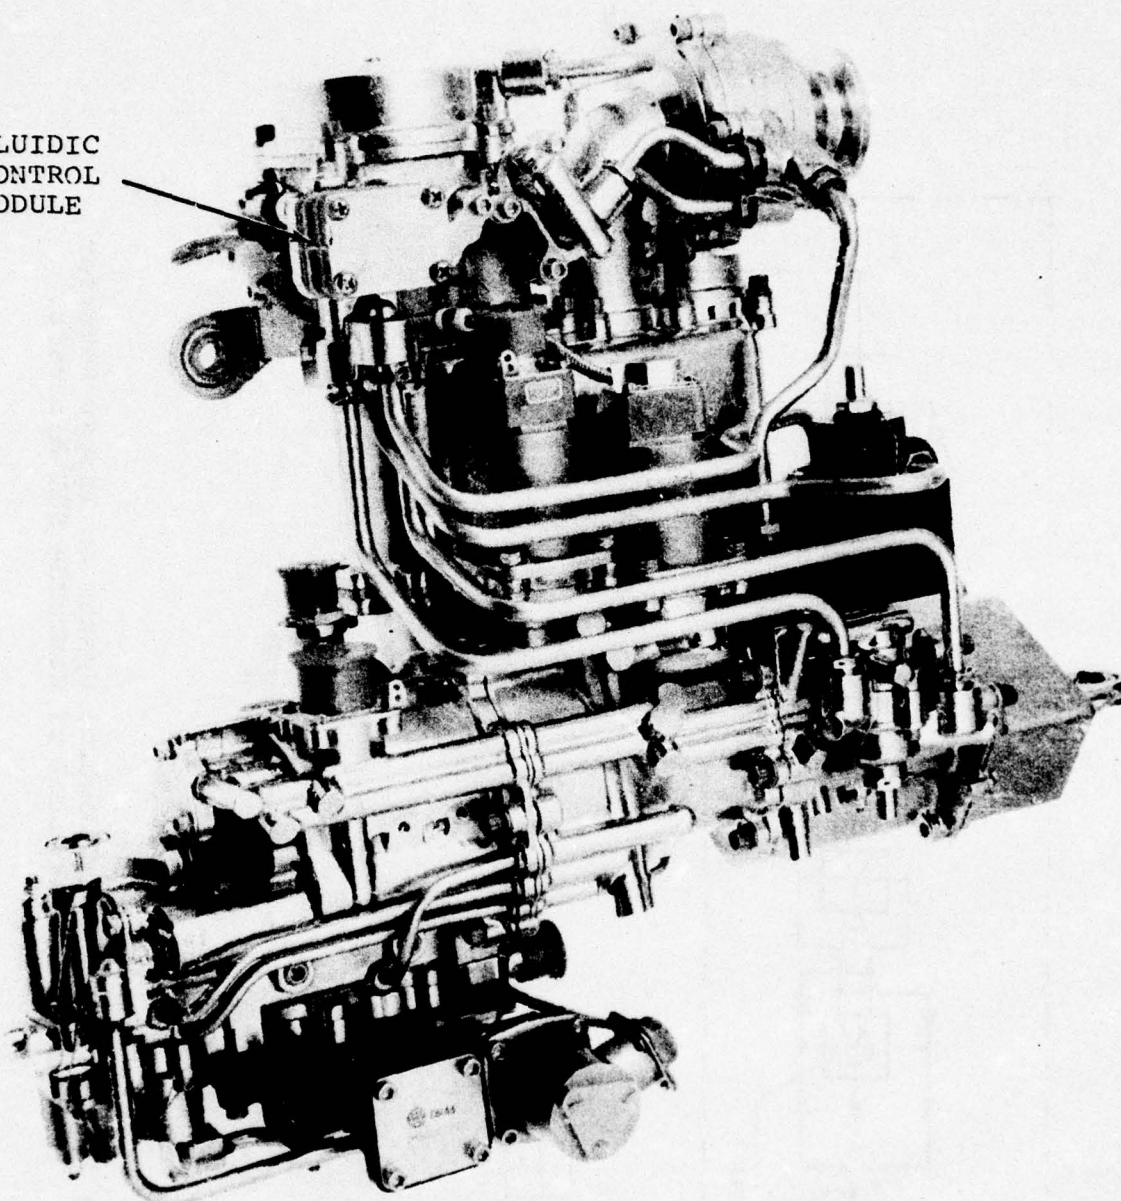
PHOTO NO. P-42148-2

Figure 17. Pneumatic Actuator of Thrust Reverser and Nozzle Control System of Concorde SST Aircraft.

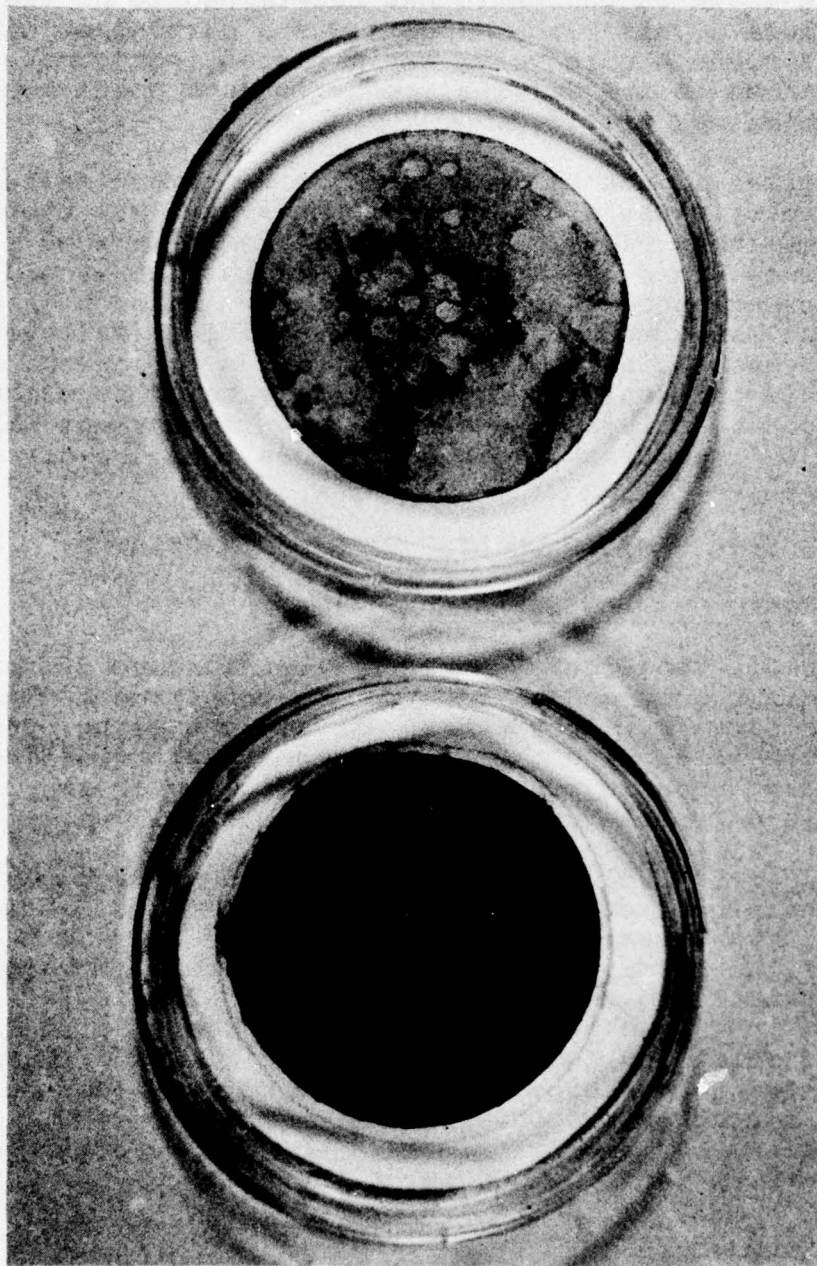
P-49786-2

The fluidic module was then backflushed and a sample of the contaminant was examined. The millipore sample is shown in Figure 18. These samples consisted of an oil residue and some fine black carbon particles. Retest of the unit after backflushing showed no significant change in the characteristics of the circuit.

Figure 18. Oil and Carbon Residue from AiResearch  
Part 126404-1-1, Serial P-111, Secondary  
Nozzle Actuator on Concorde SST Aircraft.

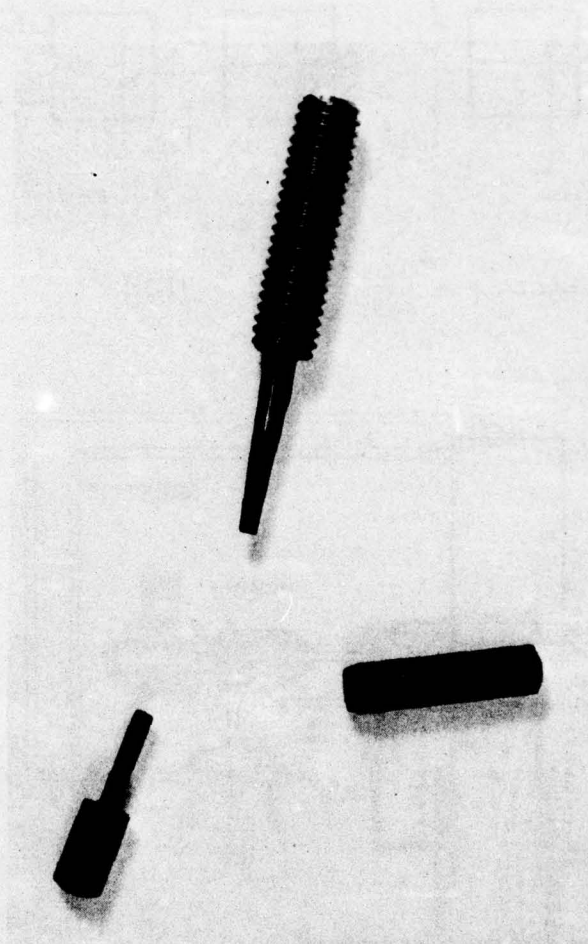
P-49786-1

Figure 19. Needle Valve Adjustment Removed from AiResearch Part 126404-1-1, Serial P-111, Secondary Nozzle Actuator on Concorde SST Aircraft.

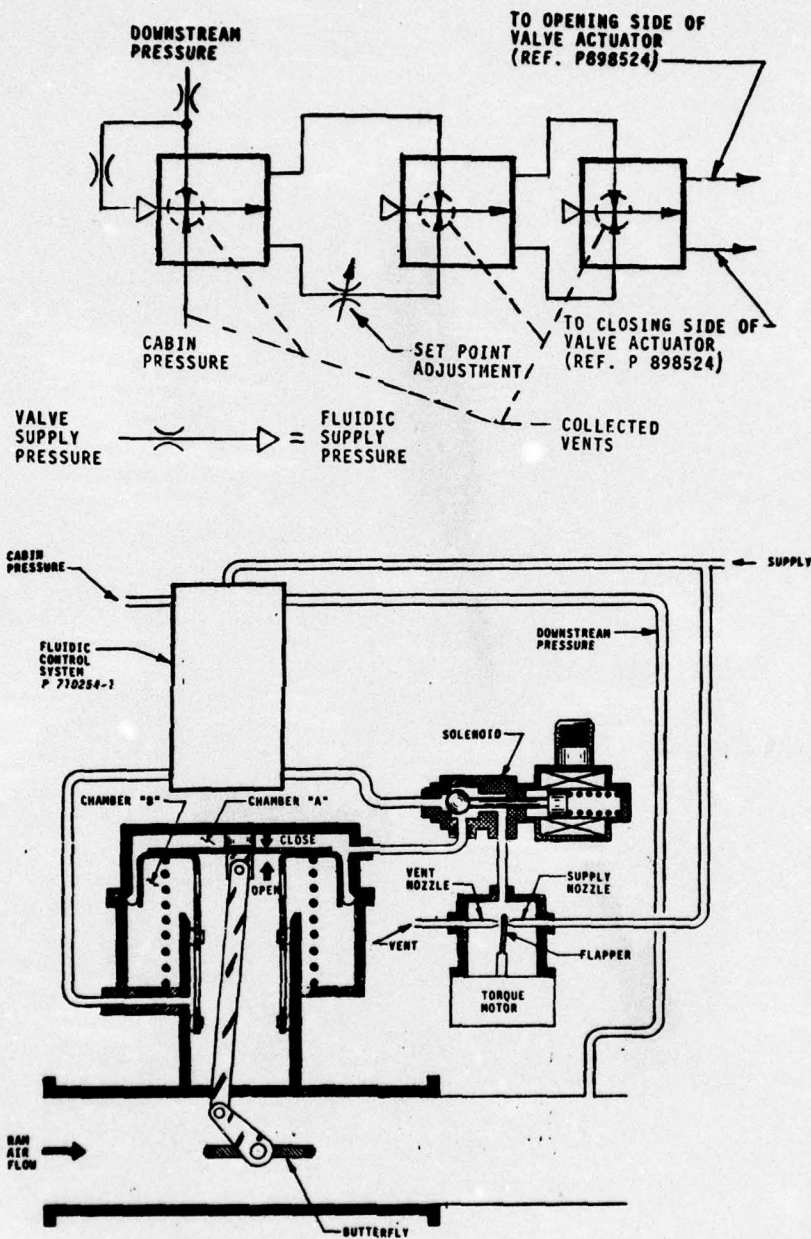
MP-43714

Figure 20. Fluidic Circuit and Schematic Diagram of Lockheed S-3A Pressure Regulating Valve (AiResearch Part 898524-1-1).

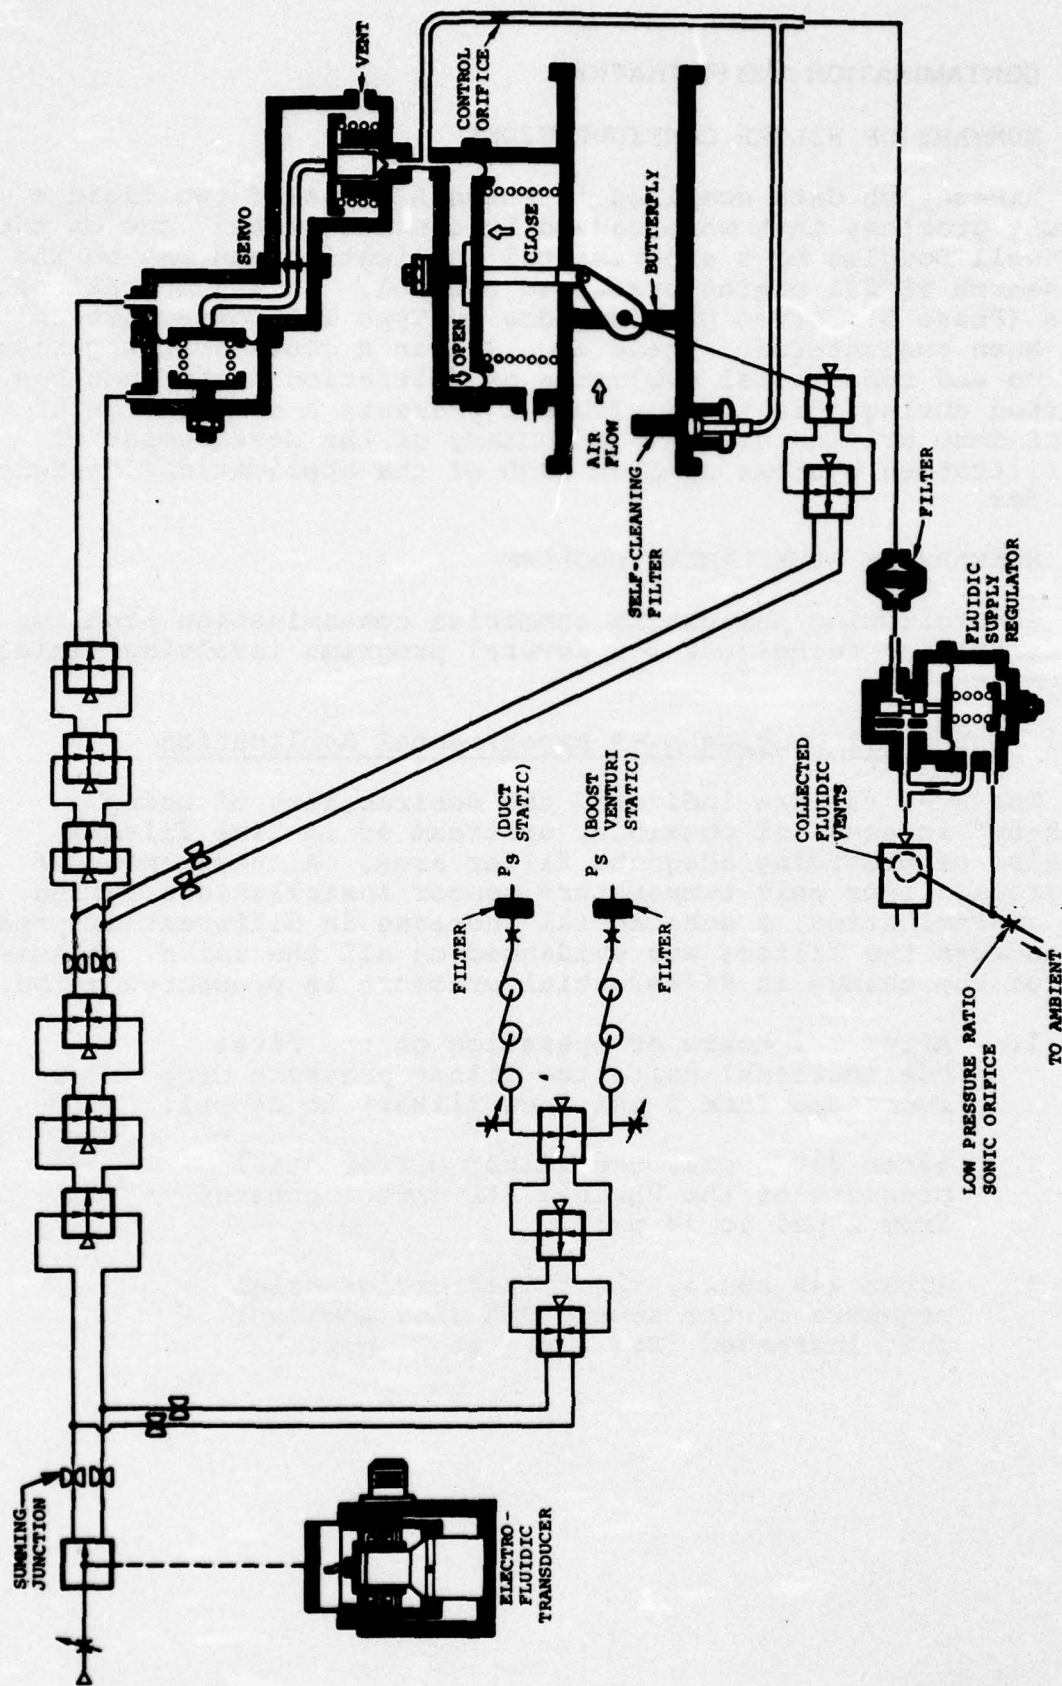
Figure 22. APU Surge Control Valve on  
North American Rockwell B-1 Aircraft

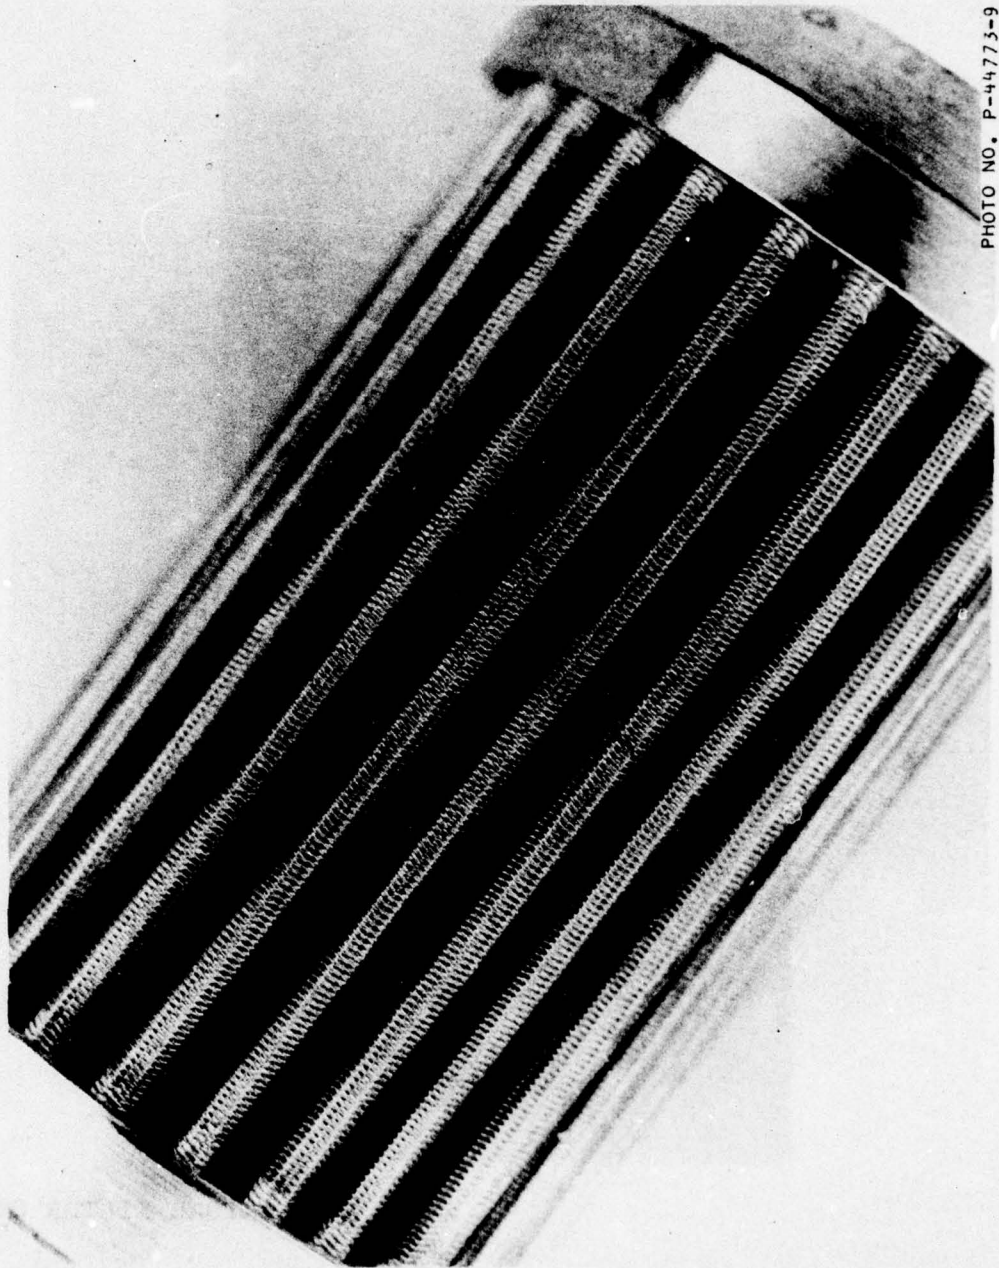
PHOTO NO. P-44773-9

Figure 24. Redesigned Intermediate Filter Screen of Fluidic Control Module on Thrust Reverser Actuation System of General Electric CF6 Engine.

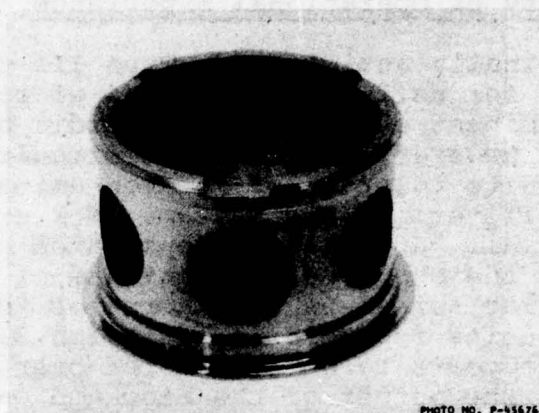
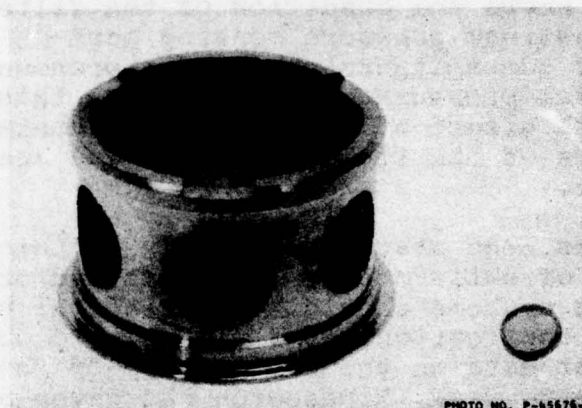
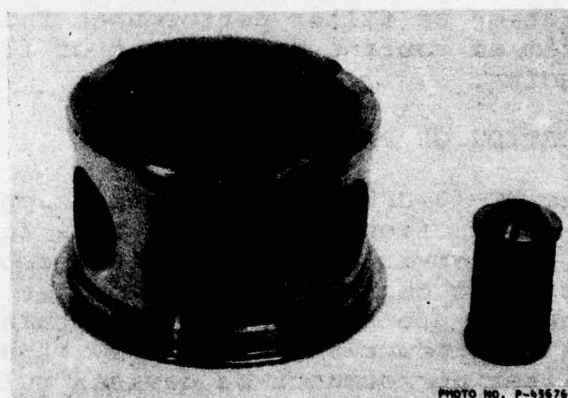
SUPPLY FILTER  
(ORIGINAL DESIGN)  
PARTS 3229099-2  
AND 3229099-3

SUPPLY FILTER WITH  
INTERMEDIATE SCREEN  
PART 3229099-4

SUPPLY FILTER  
WITH NEW  
INTERMEDIATE FILTER  
PART 3230383-1

Figure 25. Evolution of Filtration Provisions of Fluidic Control Module on Thrust Reverser Actuation System of General Electric CF6 Engine.

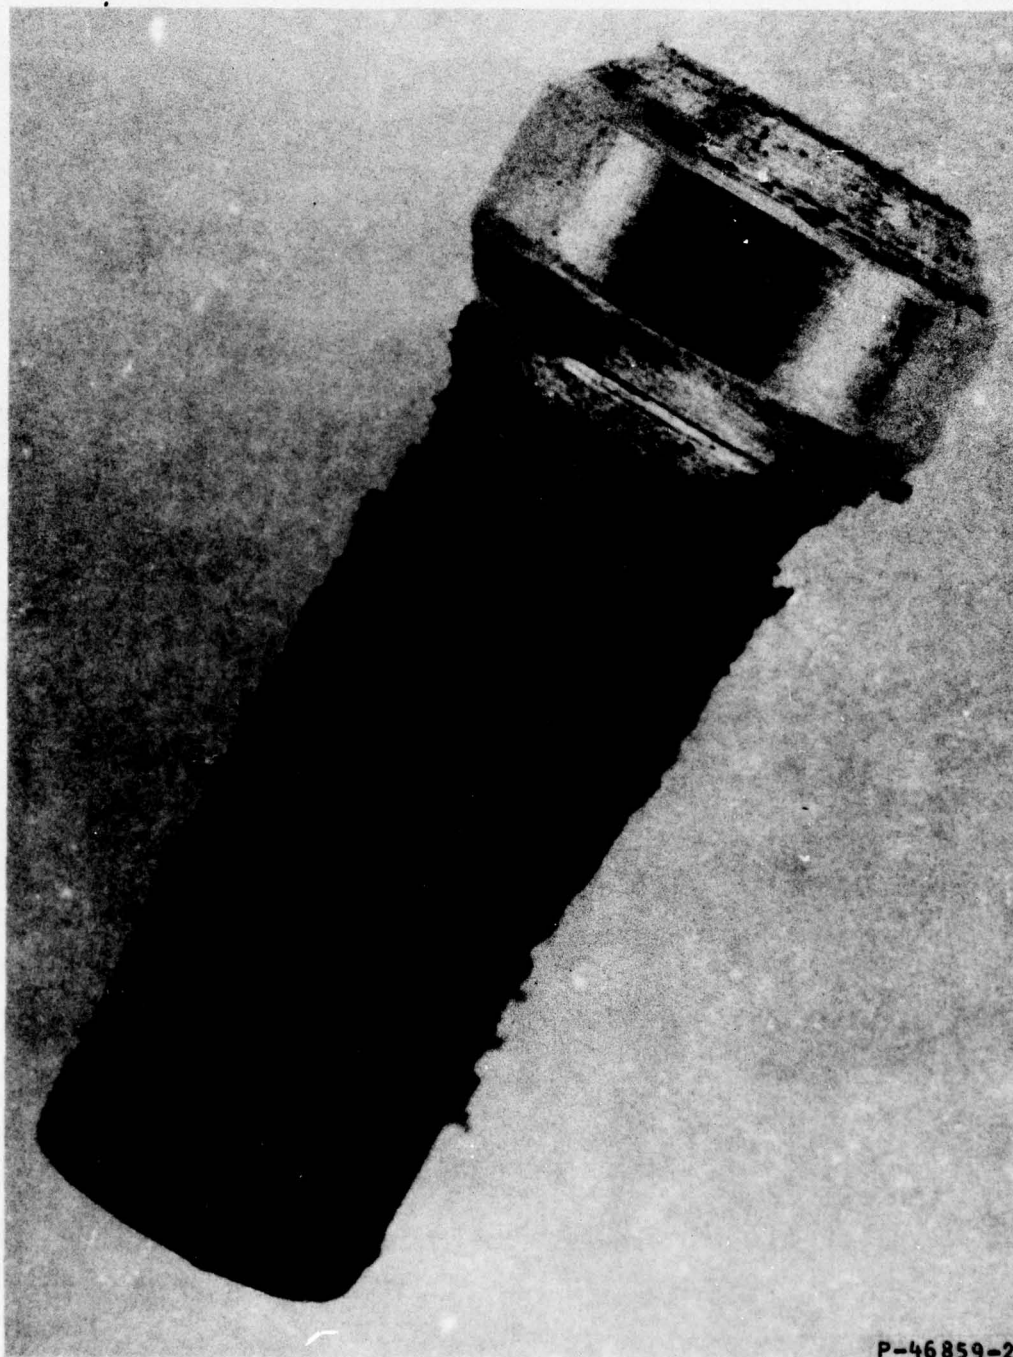
P-46859-2

Figure 27. AiResearch Filter Element 882066 Removed  
From Actuator Assembly 126366, Serial AEX-10043  
Thrust Reverser on General Electric CF-6 Engine.

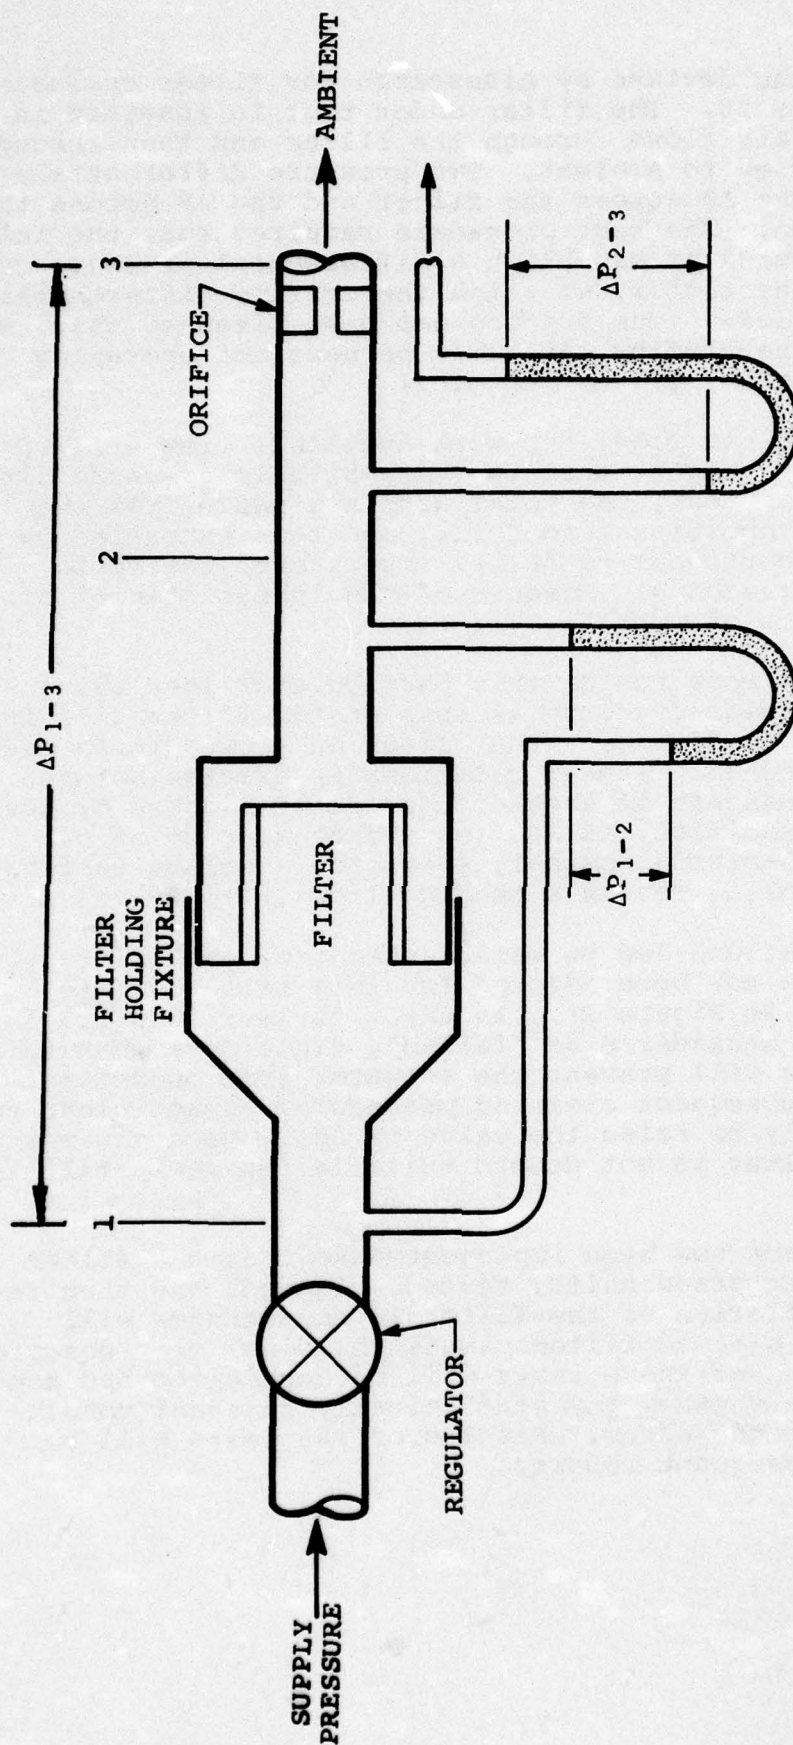
Figure 28. Filter Performance Test Setup.

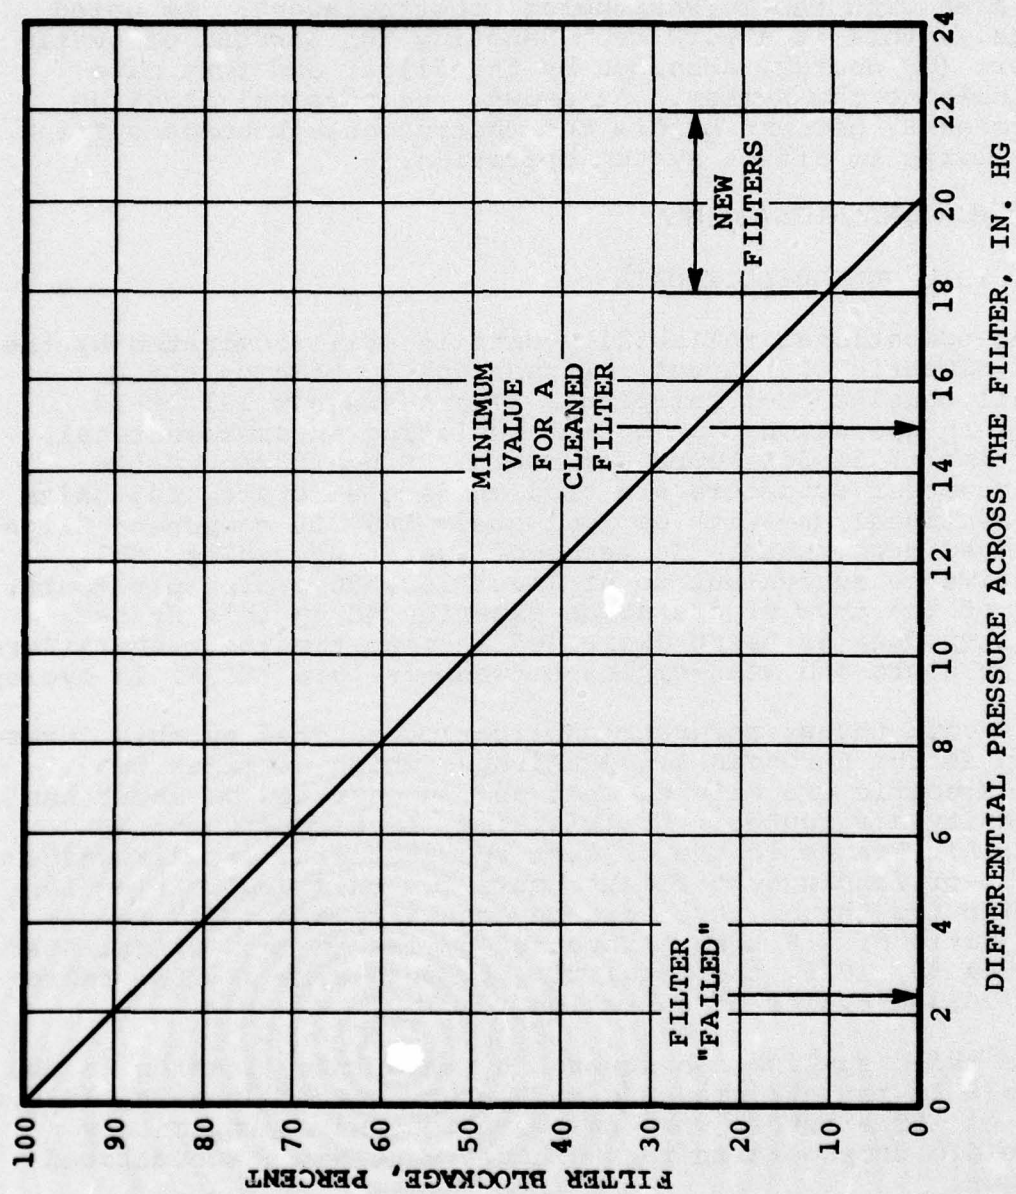
Figure 29. Filter Calibration Curve.

It is interesting to note that, although a new filter absorbs approximately 17 percent of the work energy available from the air supply in this test procedure, the filter must reach the point of absorbing over 60 percent of the input energy before it will prevent operation of the actuator. This is shown in Figure 30 which plots the percent of physical blockage of the filter area with the corresponding "obstructance". As noted previously, this is a work term denoting the percent of available work (or energy) absorbed by the filter and thus made unavailable to the system. As shown, the physical blockage must exceed 87 percent before the obstructance becomes sufficiently large to affect system operation.

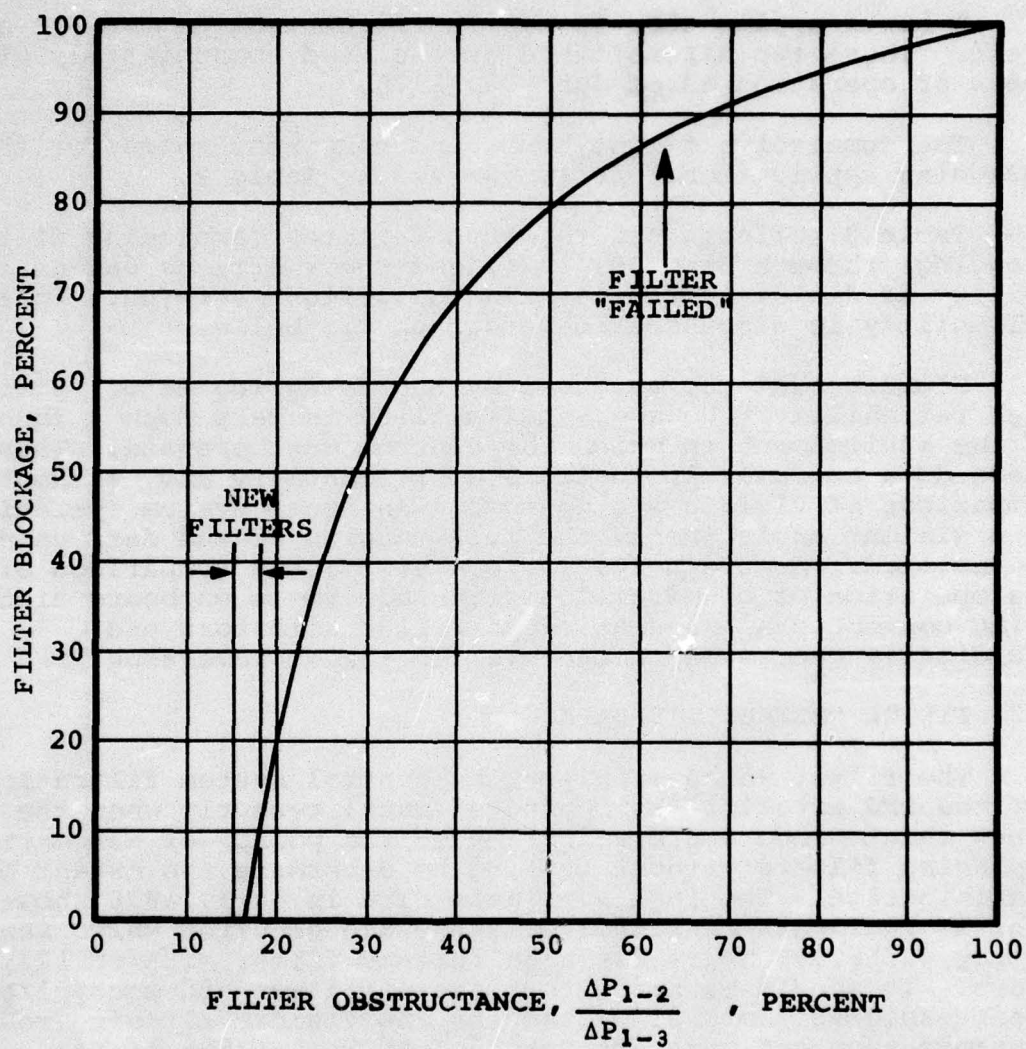
Figure 30. Filter Blockage Vs. Obstructance.

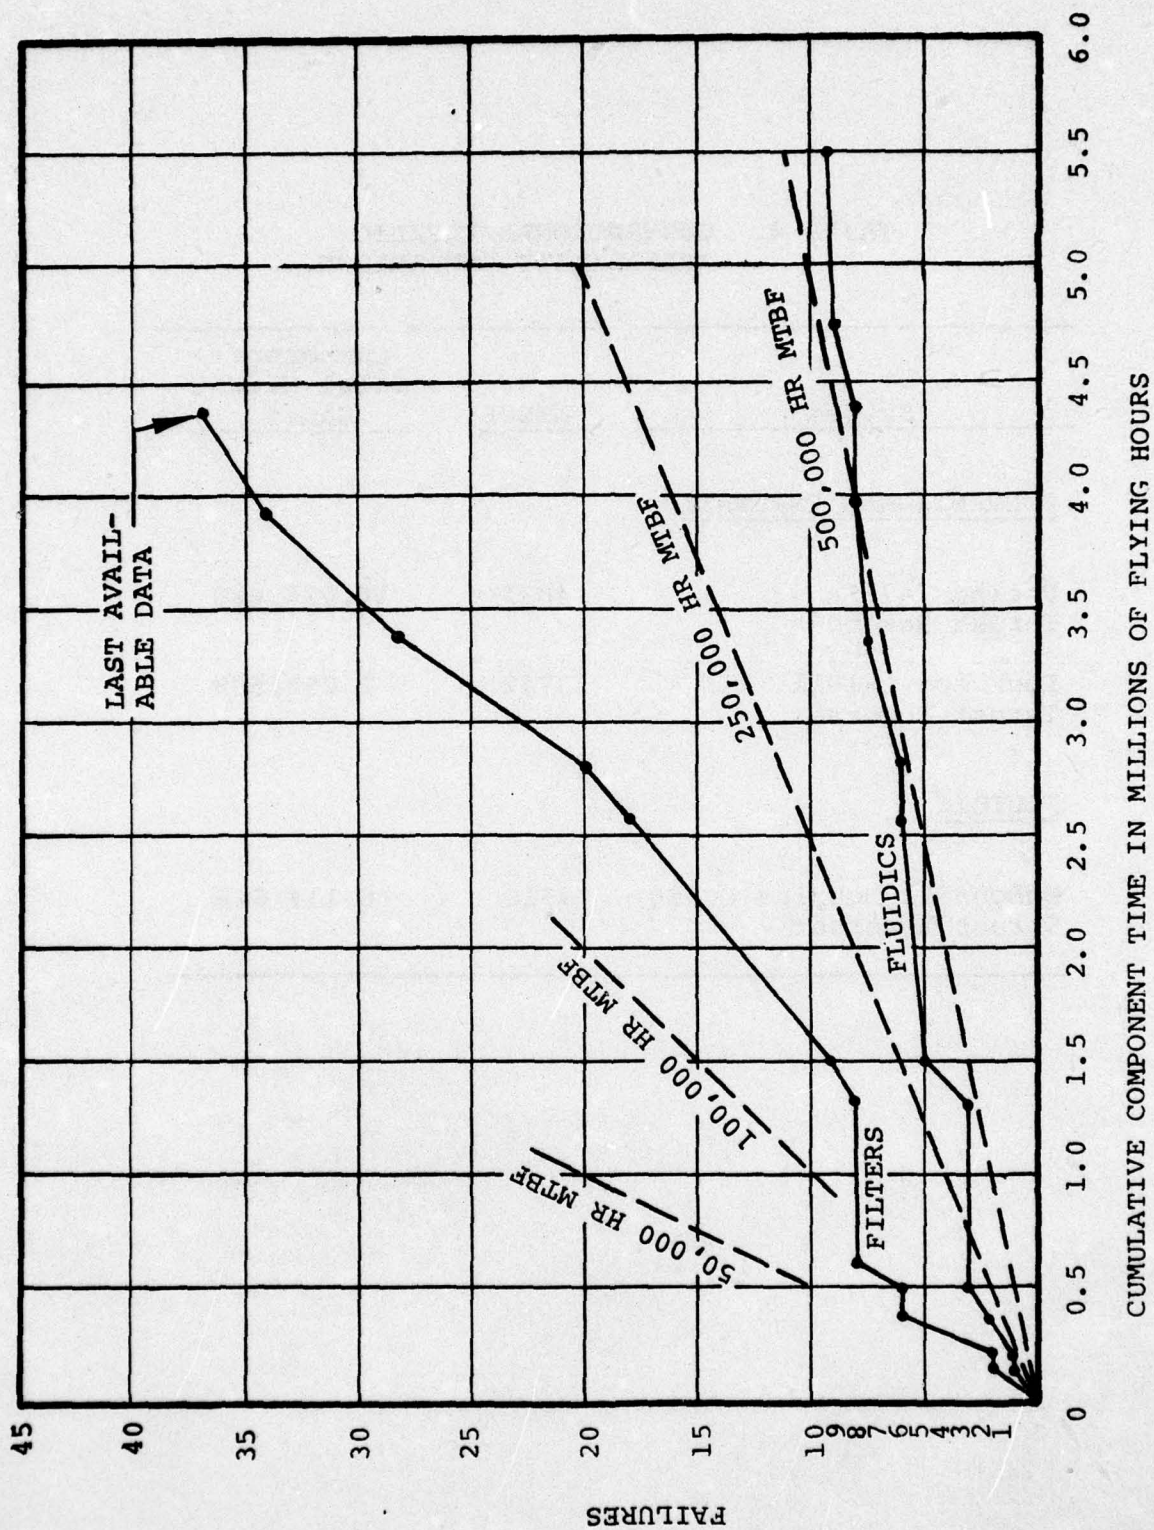
Figure 31. Sequential Analysis Chart.

It should be noted that the plot for the filters was terminated about the first of 1976 when filter data became unavailable.
